The Life Cycle of Your Roof

Homeowner's Guide: What to Expect From Your CertainTeed Roof

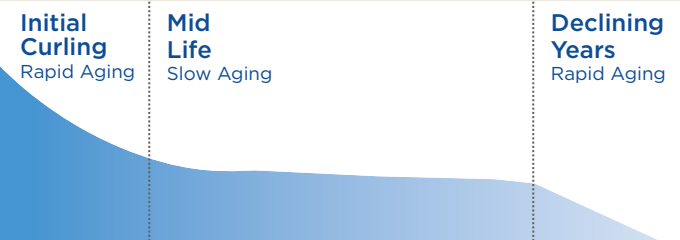
THE LIFE CYCLE OF A ROOFING SHINGLE

When your new roof was installed, friends and neighbors may have remarked how it enhanced the beauty of your home. However, research indicates that aging begins soon after the shingles are installed and progresses rapidly during the initial curing phase of its life cycle. During this stage, granule loss may occur, small blisters may develop, or the shingles may curl slightly at their edges. You may even notice that this curling is more pronounced during cold weather and the shingles may lie flat as temperatures rise. The good news, however, is that after this curing stage the shingles enter a long period of slow aging, which lasts for the major portion of the shingle's natural life.

During the “mid-life” period, aging continues at a much slower rate. The cracking or granule loss still occurs but does not increase at a noticeable rate. Only after this long period of mid-life does the aging process begin to accelerate once again as the shingles enter their declining years. It’s during this period that homeowners normally think about replacing their roofs.

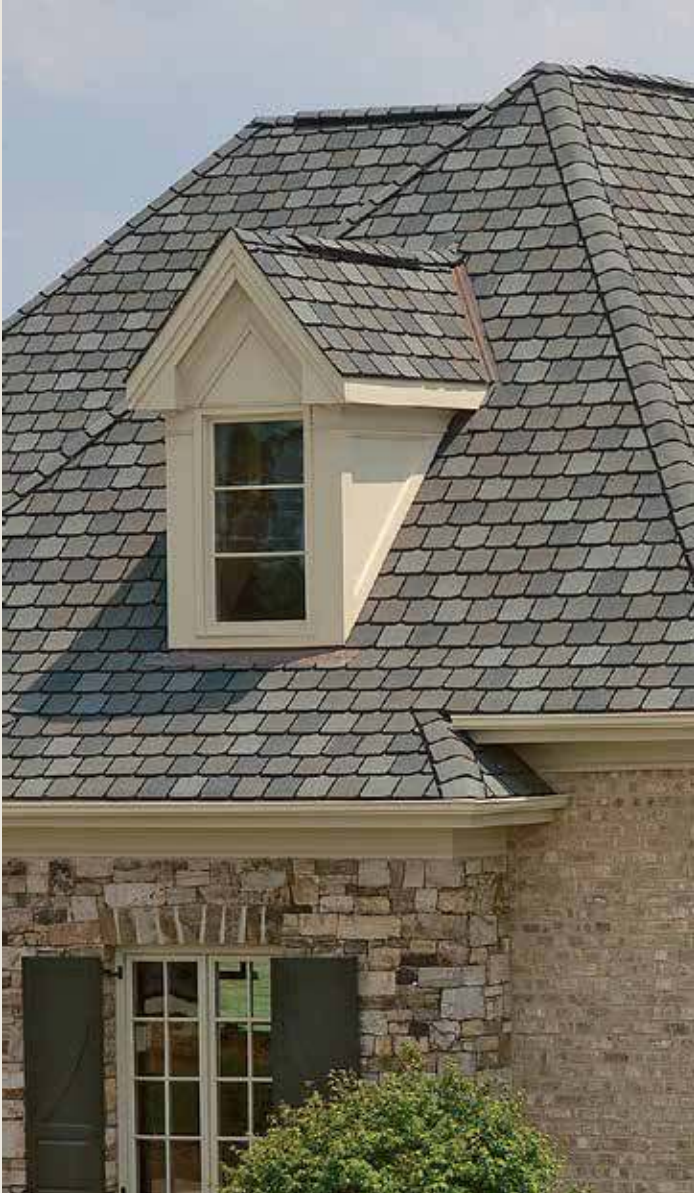
CURLING

Initial Curling

Mid-Life

Declining Years

CURLING: As the asphalt hardens over time, the granules which were once securely embedded begin to break away. Occasionally you may have seen the colored granules in your gutters. Also, as this hardening advances, the asphalt layers begin to shrink. Of course, all of this is occurring at a microscopic level and is not something which will be noticeable on a daily basis. As the asphalt layer shrinks, it is being countered by the shingle reinforcement, which resists shrinking. We now have a situation in which the top and bottom coatings are shrinking and the

reinforcement is remaining stable. As a result, the edges of the shingle may begin to curl over time. In addition, organic shingles may exhibit signs of curling which might be considered excessive, however, this is not a manufacturing defect and would be considered part of the normal weathering process of organic shingles.
